# UNDERWATER BRIDGE INSPECTION REPORT

STRUCTURE NO. 66532

227<sup>th</sup> STREET

STRAIGHT RIVER

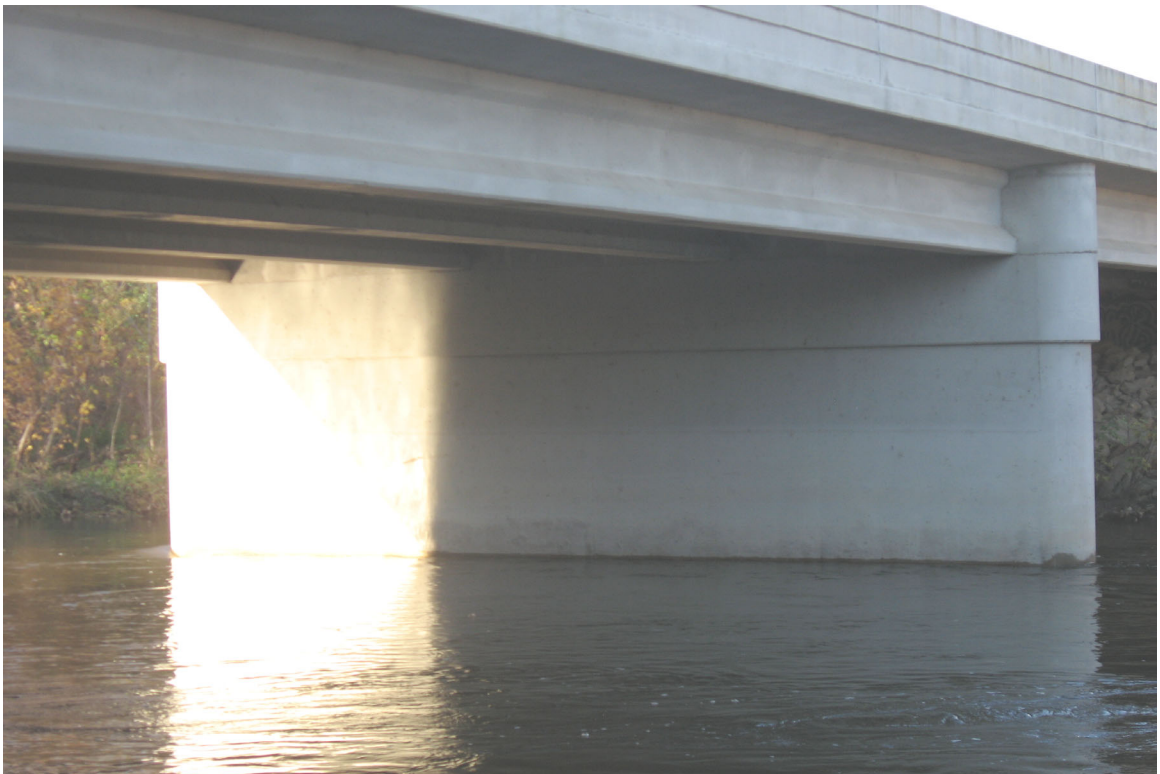
- (A) The concrete of the piers was smooth and sound with no notable defects.
- (B) A light accumulation of timber debris consisting of 8-inch-diameter and smaller branches was observed at the upstream nose of Pier 1 extending from the channel bottom to 1 foot below the waterline.
- (C) A heavy accumulation of timber debris consisting of 2 feet in diameter and smaller logs and branches was observed at the upstream nose of Pier 2 extending from the channel bottom to 4 feet above the waterline.

Photograph 2. View of Pier 1, Looking Southeast.

- Light accumulation of timber debris consisting of 8 inch diameter and smaller branches was observed at the upstream nose of Pier 1 extending from 1 foot below the waterline to the channel bottom.

- (A) Remove accumulations of timber debris at both piers to alleviate further accumulation, scour influence, and any excessive lateral force on the piers.
- (B) Reinspect the submerged substructure units at the normal maximum recommended (NBIS) interval of five (5) years.

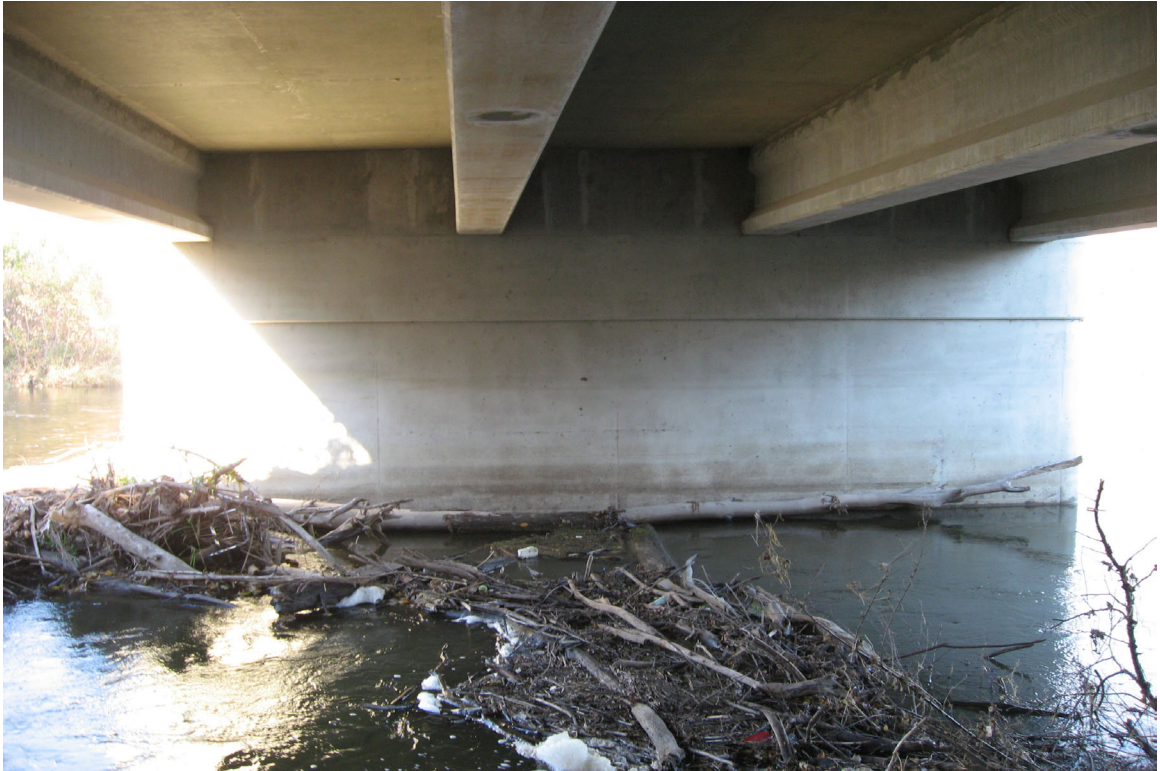
Photograph 3. View of Pier 2 and Timber Debris, Looking West.

- Heavy debris 2 feet in diameter and smaller logs and branches was observed on the upstream side of Pier 2, extending from the channel bottom to 4 feet above the waterline.

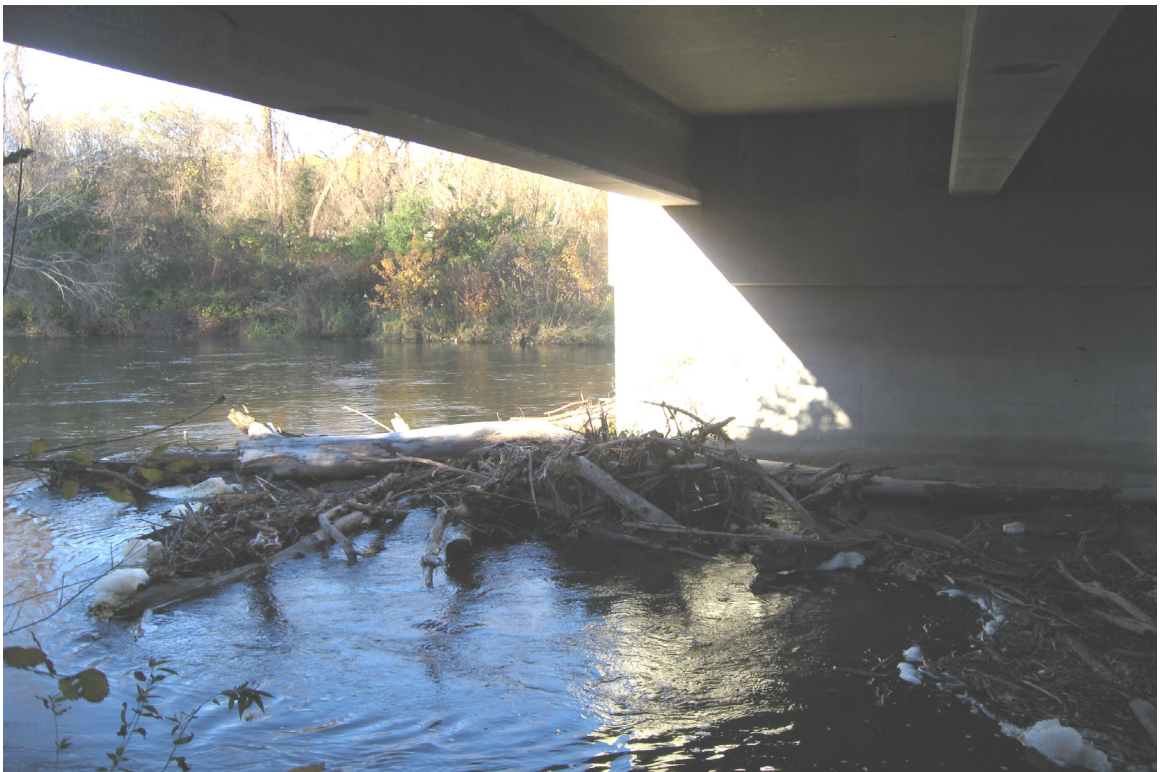
Photograph 4. View of the Upstream End of Pier 2 and Timber Debris, Looking Southwest.

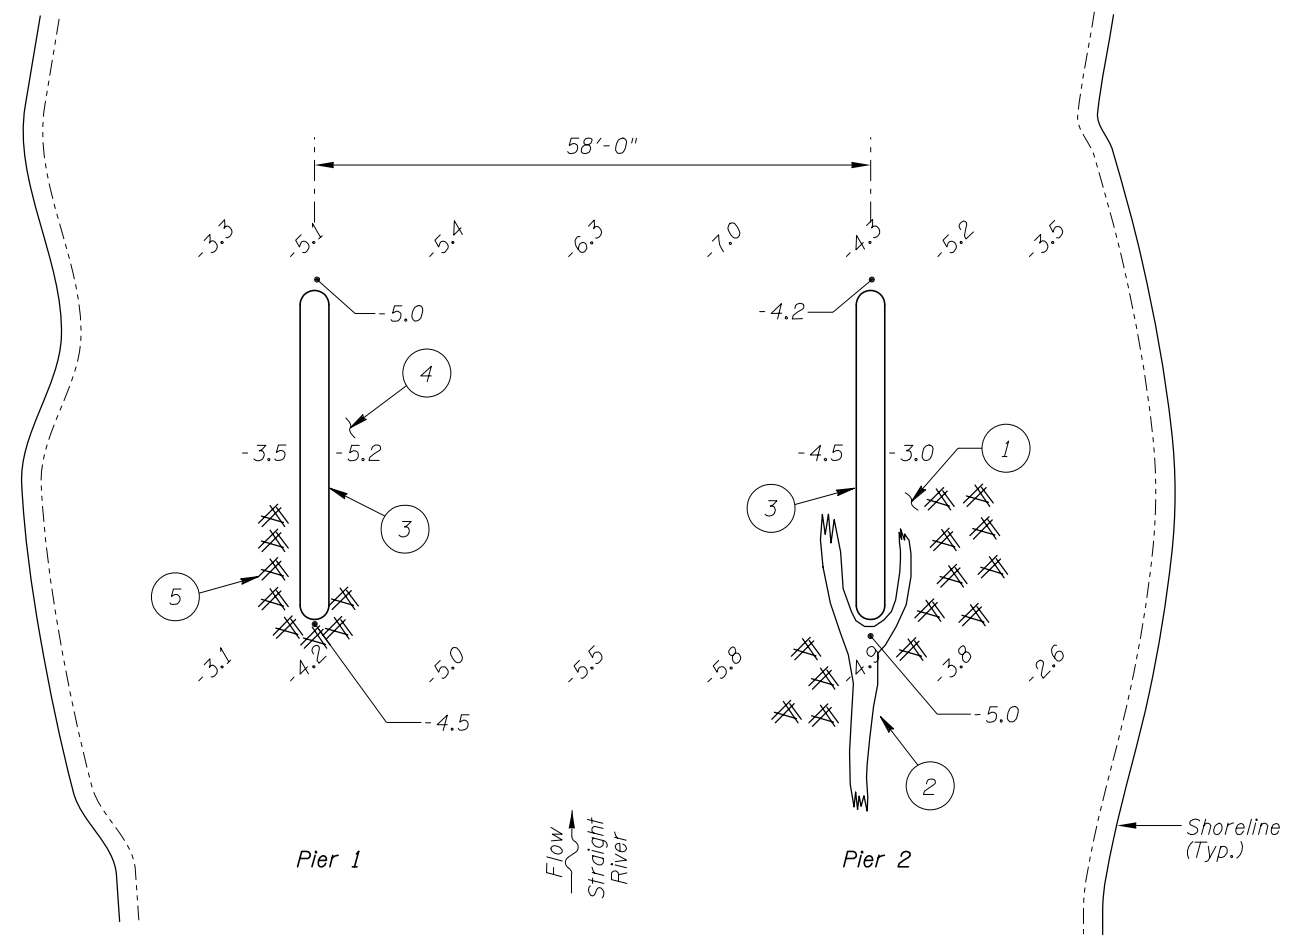
SOUNDING PLAN

- Channel bottom consisted of sft silty infilling and organics with 6 inches of probe rod penetration. At the upstream nose, rock was reached 1 foot below the channel bottom. Also at the midpoint on the channel side, rock was reached at 1.5 feet below the channel bottom.

- Concrete was smooth and sound on both piers.
- The channel bottom at Pier 1 consisted of firm rock and gravel with no probe rod penetration from the upstream nose to the midpoint, and sand silty infilling with 3 inches of probe rod penetration from the midpoint to the downstream nose.
